Report No. FT-R1005

Testing of James Hardie NZ ExoTec façade panel top hat rainscreen façade system in accordance with AS/NZS 4284:2008 'Testing of building facades', plus extension.

Project: Generic ExoTec façade panel rainscreen system

Client: James Hardie NZ

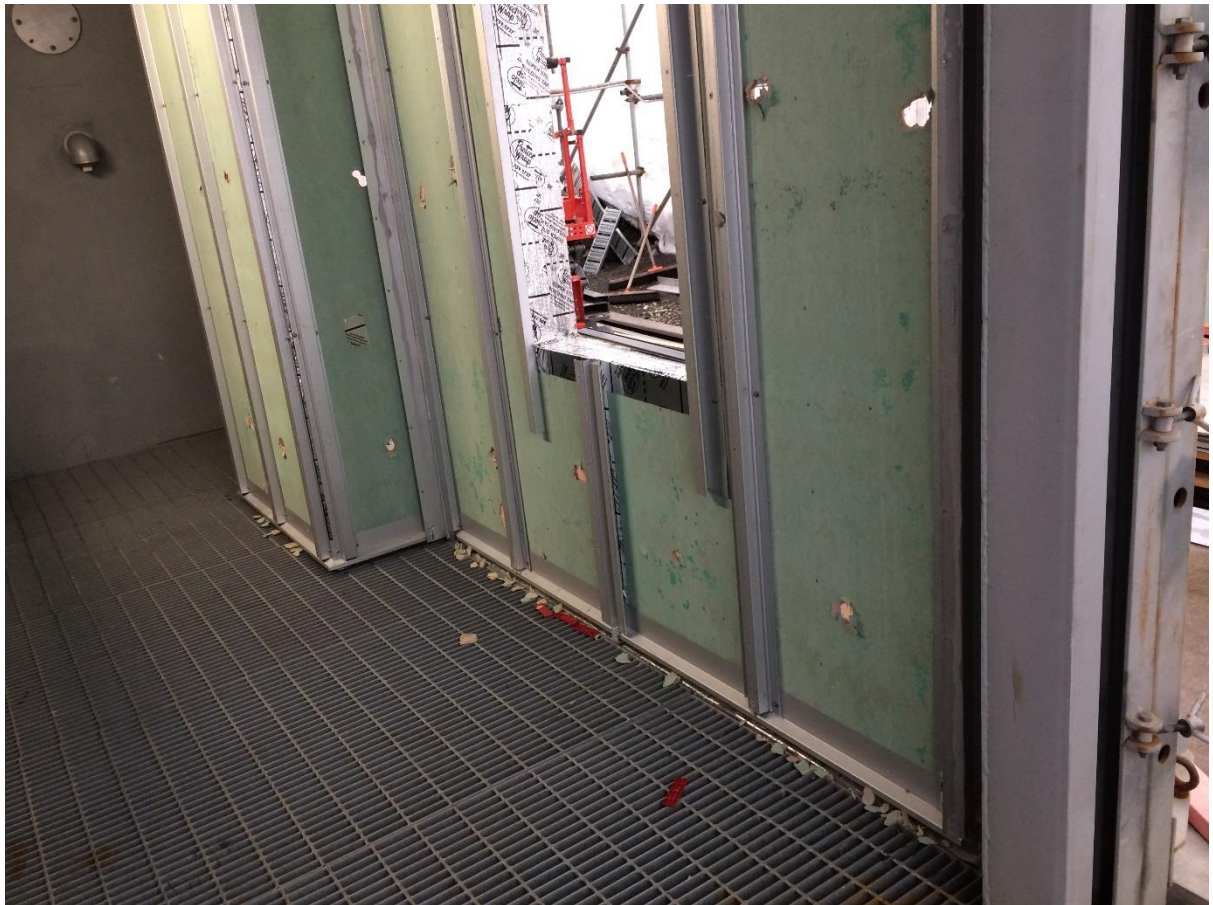
Figure 6: Top hat sections on wet side of cladding, with cladding removed and holes in RAB board during disassembly.

Holes were punched in the RAB board to establish an air pressure across the cladding, to allow a modification of the wetwall test of the E2/VM1 testing to be undertaken.

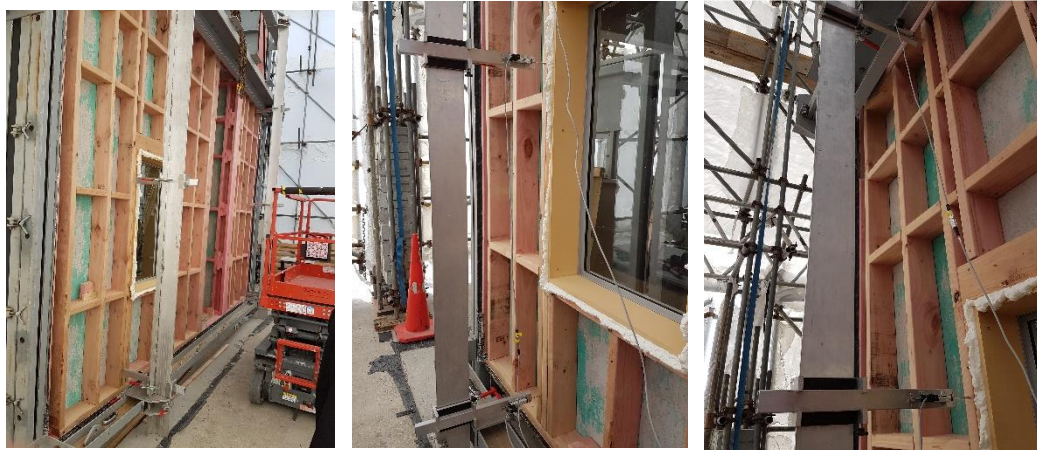
Figure 9: Photos of displacement transducers on stud beside window (Stud 1)

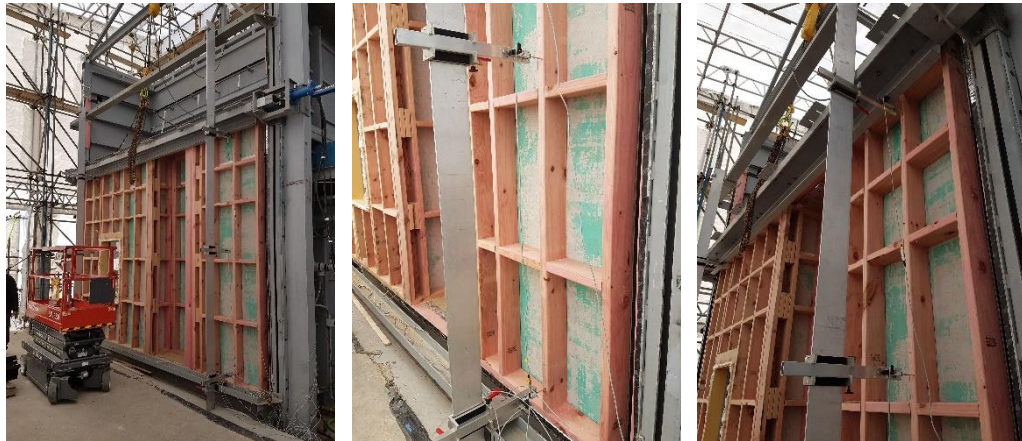
Figure 10: Photos of transducers on stud in field of wall (Stud 2)

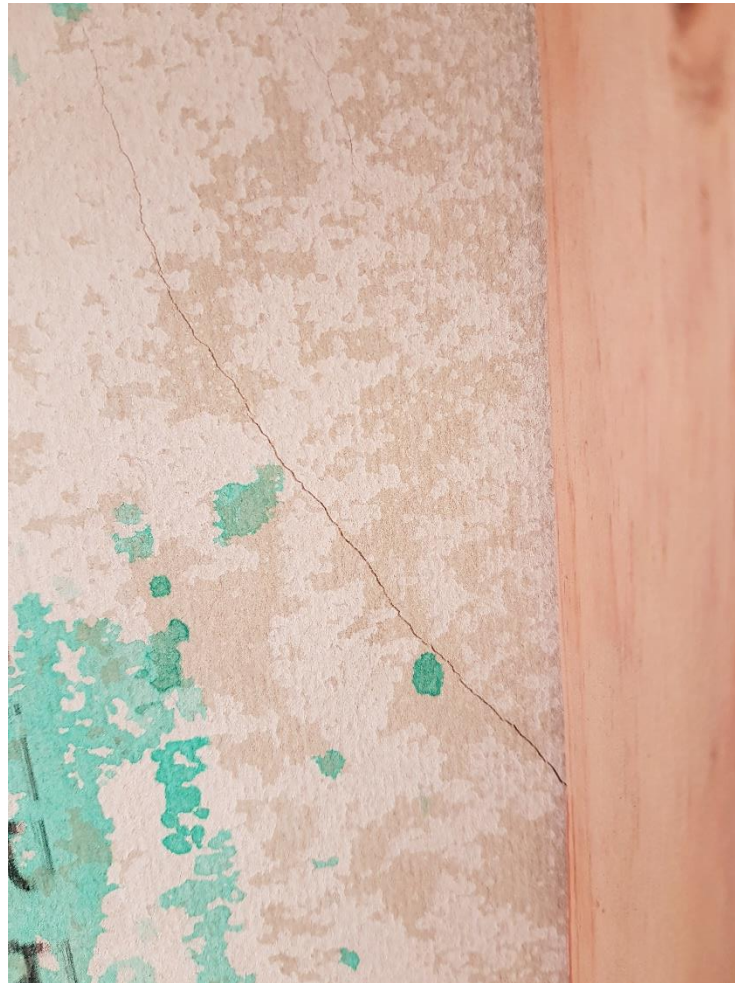
The seismic deflection testing at ±20 mm was undertaken straight after the SLS seismic deflection of ±18 mm, and resulted in a fine crack occurring at the head of the window. The cyclic water penetration test was performed following the seismic test with the results as follows.

Cyclic water test			
Phase	Air pressure (Pa)	Duration	Result
	0	5 minutes	No water leaks
1	525 – 1050	5 minutes	No water leaks
2	700 – 1040	5 minutes	No water leaks
3	1050 – 2100	5 minutes	Dampness on back of RAB board around crack in RAB board. No water leakage.

There was minor damage to the RAB board from the end of the window head flashing where the RAB board cracked for an approximate distance of 200 mm. See photo in Figure 12. This extended and widened the crack first noticed following the ± 20 mm seismic displacement.

Figure 12: Crack in RAB board following ULS seismic testing on system

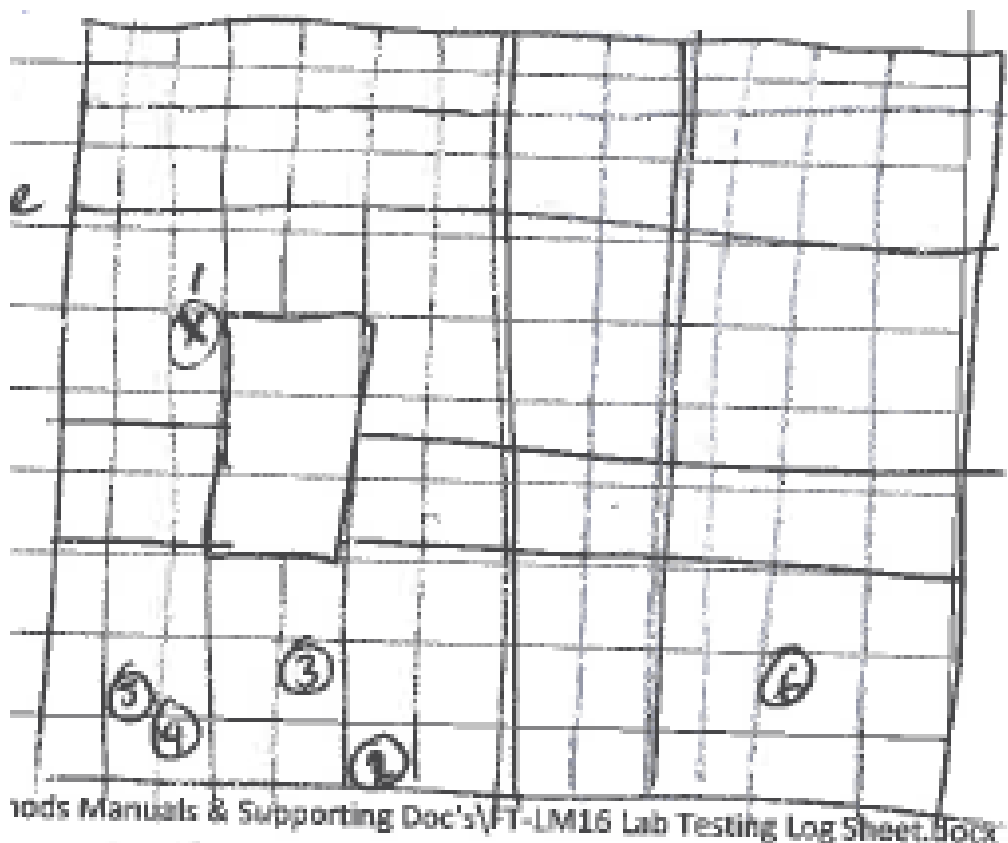
Results showed that the crack from the LHS of the window head flashing (at 1) allowed some seepage of water through the RAB board. Water seeped through the joint between the stud and the bottom plate at (2), and water splattered up from the footer flashing at points 3, 4 and 5.

Point 6 had water that was dripping down inside the metal top hat batten, coming out through the defect in the RAB board. This water was contained, and did not spatter on the back of the RAB board.

The test would have passed this section of the extended E2/VM1 'WeatherPlus' test, since all this water was managed appropriately.

Figure 16: Sketch of water leak locations during the extended E2/VM1 'WeatherPLUS' test.

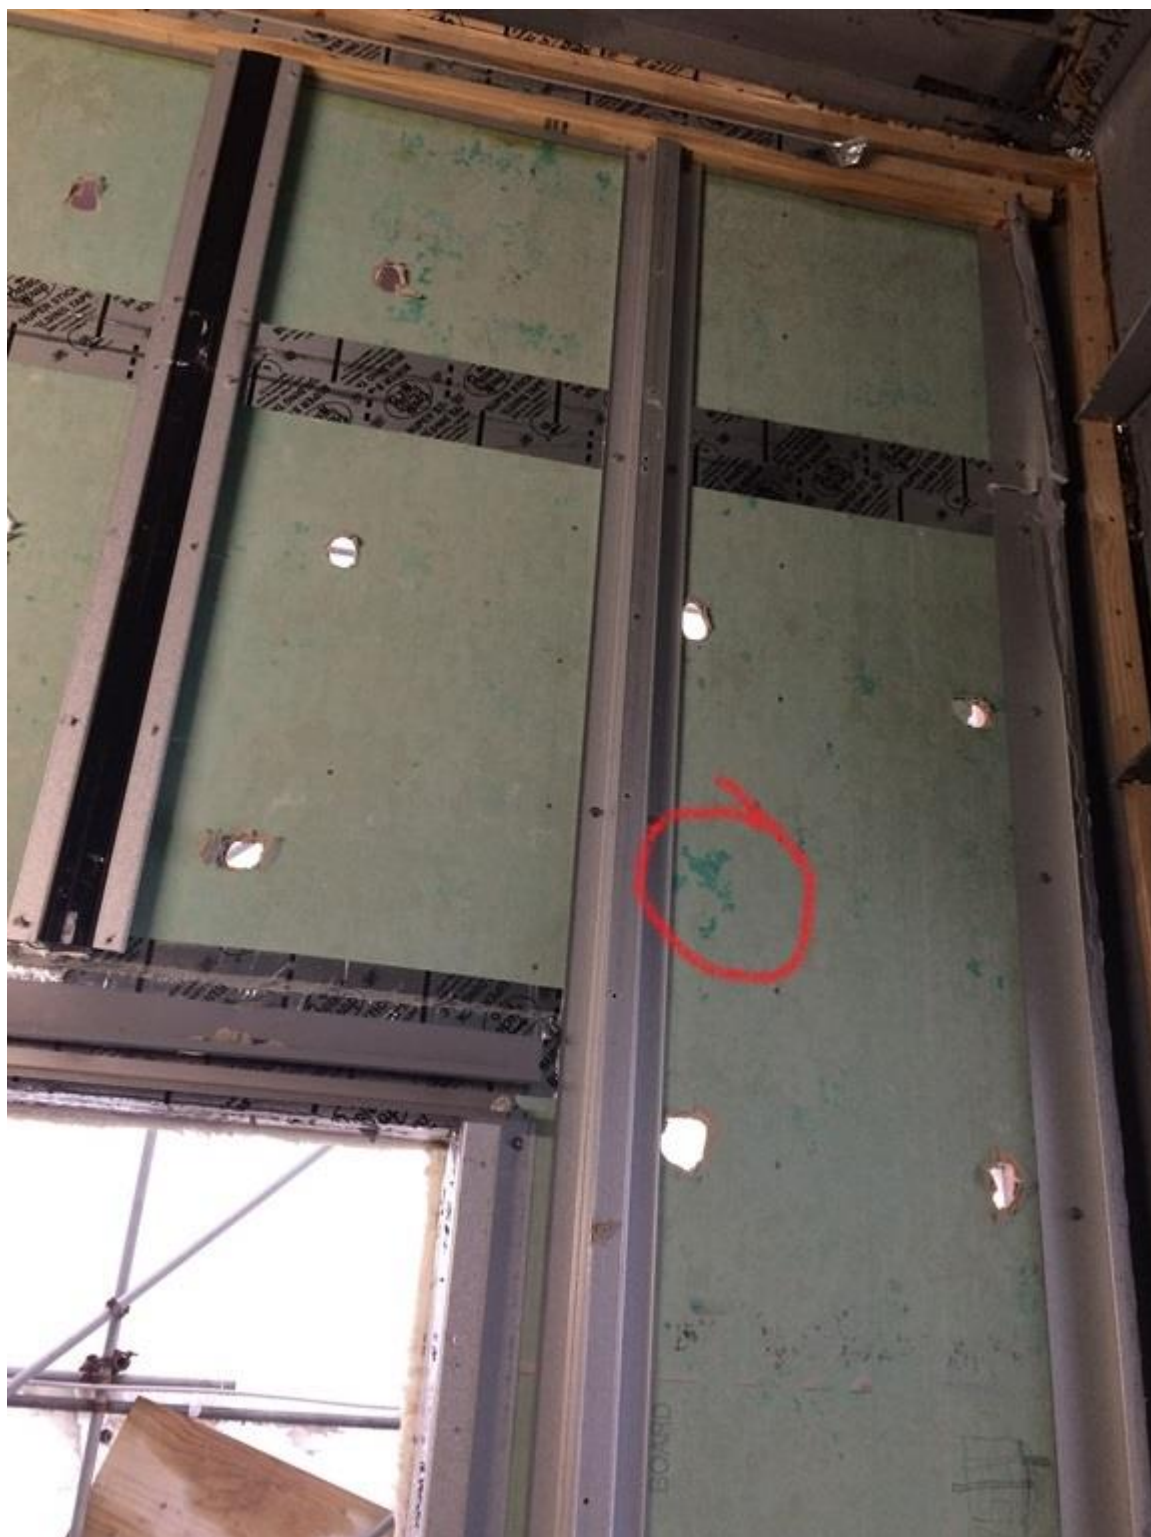
Figure 17: View from wet side of RAB board after removal of cladding, showing holes made in RAB board, and the damp patch from water seeping through the crack emanating from the head flashing.
