## MARANUI SURF

# Club

## CASE STUDY

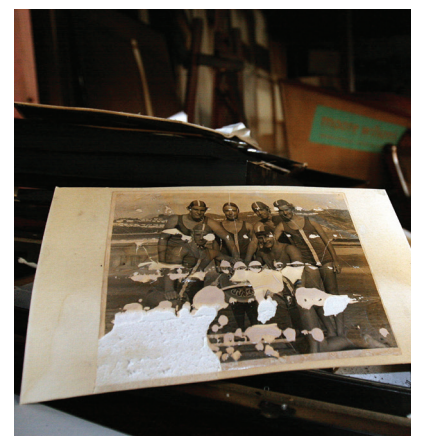
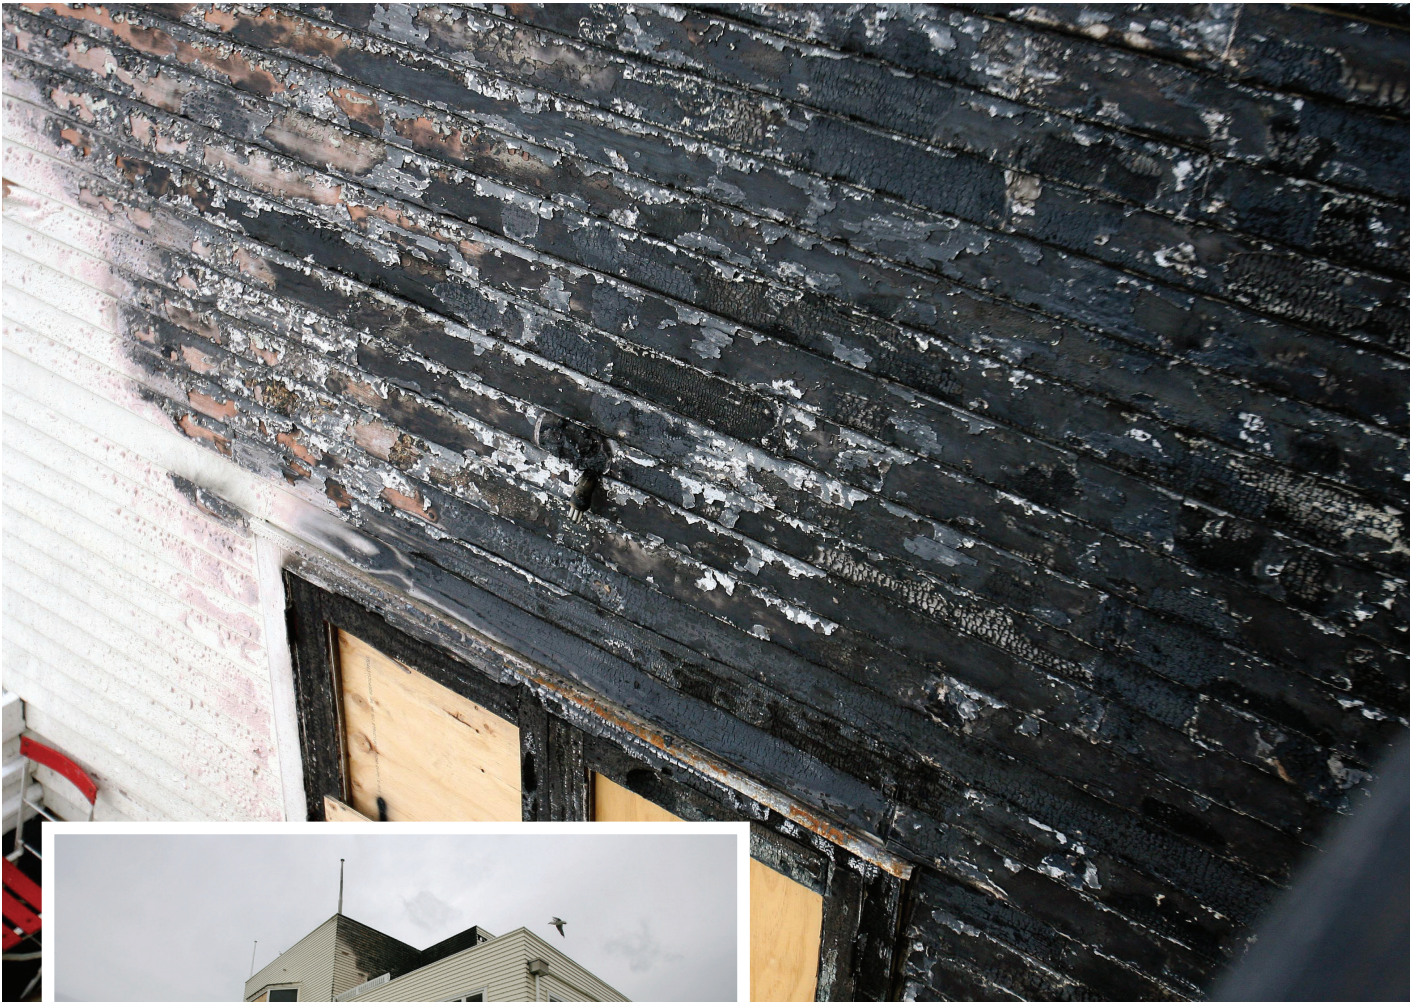
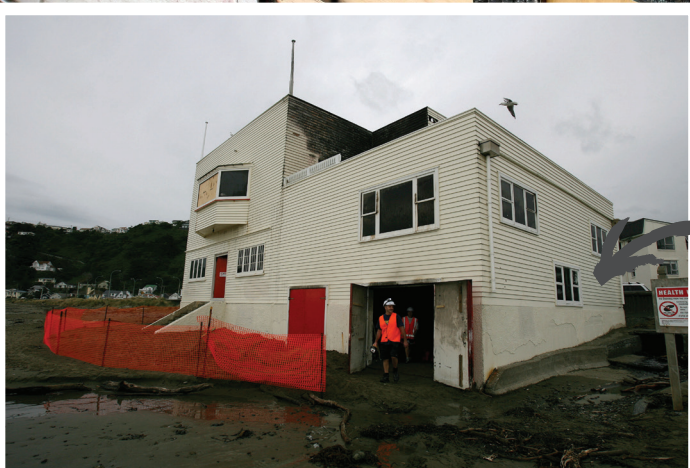
The photos show the charred timber weatherboard right next to undamaged Linea Weatherboard and 7.5mm James Hardie Weatherboards. The best direct comparison is where the fire was less intense – the heat

transference has caused the paint to bubble and crack on the timber weatherboards, while the Linea Weatherboard is as good as new. The whole seaward side, which was completely reclad in Linea Weatherboard, shows almost no sign of damage, even though there was complete loss of 20% of the interior.

While Maranui Surf Life Saving Club lost many irreplaceable pieces of memorabilia, it was saved by the quick arrival of the fire service and the high fire rating of Linea Weatherboard, which stopped the flames from taking hold and completely destroying the building.
